Intel[®] Pentium[®] II Xeon[™] Processor Specification Update

Release Date: October 2000

Order Number: 243776-025

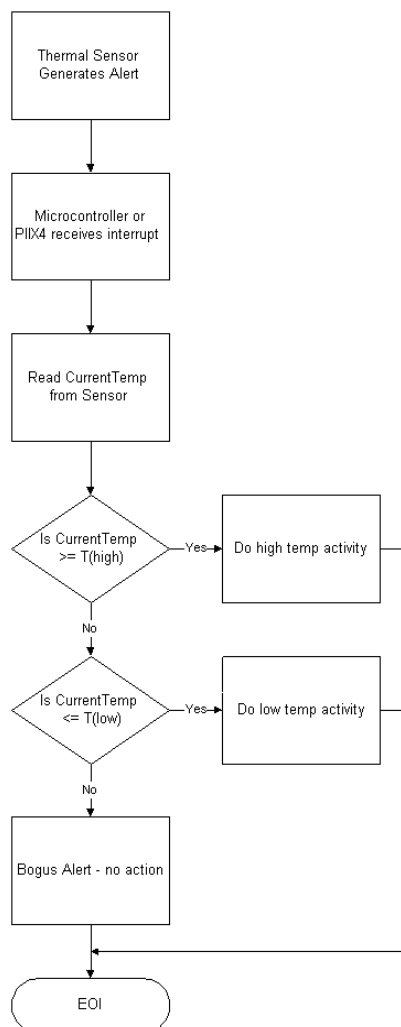
Figure 2. Workaround Flowchart: SMBALERT#-Driven System

D30. Thermal Sensor May Assert SMBALERT# Incorrectly

Under the conditions described below, the thermal sensor incorrectly generates the SMBALERT# interrupt. All of the following conditions must be met to trigger a false interrupt:

Workaround: Three different (mutually exclusive) workarounds are possible:

1. Before servicing an interrupt from the thermal sensor, read and compare the processor thermal reading with the threshold limits (T_{HIGH} or T_{LOW}). Figures 2 and 3 provide basic flowcharts for the implementation of this workaround in an interrupt driven system.
2. If the firmware implemented polls the Status Register only, then before taking any action, re-read the temperature register and do a comparison with the alarm threshold limits (T_{HIGH} or T_{LOW}) to determine if the value is actually still within the temperature window.
3. Use a temperature polling scheme to monitor the processor temperature
